Inspection Report
95 Old Stage Road
East Brunswick NJ
Scott Frederick

Prepared by: The Inspection Guys
www.inspectionguys.com
16 Mt. Bethel Road, Suite 171
Warren, NJ 07059
800-903-0670 Fax: 732-238-7092

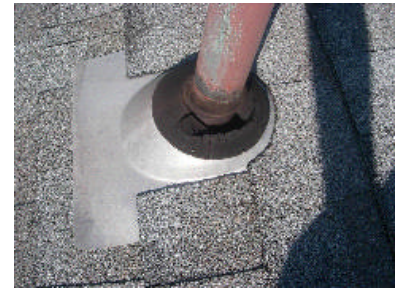
- Sealing of flashings is needed at plumbing, vent pipes, chimney, wall, valley seams, (skylights if present) and any other through roof projections.

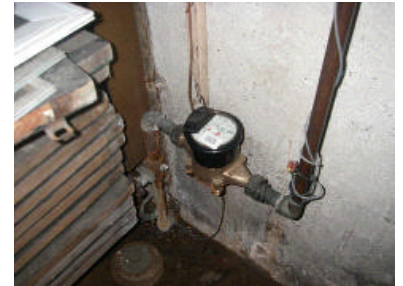
- The visible material of the main line / pipe coming in from the street appears to be copper.
- **The main valve is located at the basement.**

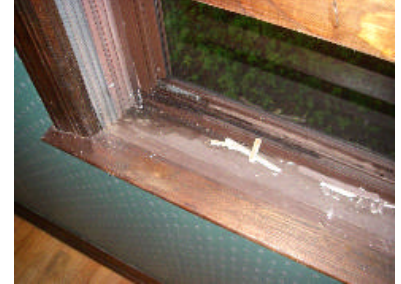
- Exterior frame weathering and some deterioration was observed at the window sills. Recommend repairs / maintenance as needed. Water penetration may have occurred.
- The *****windows would not remain in the open position. Broken or worn sash cords or springs were noted. Recommend repairs as needed.

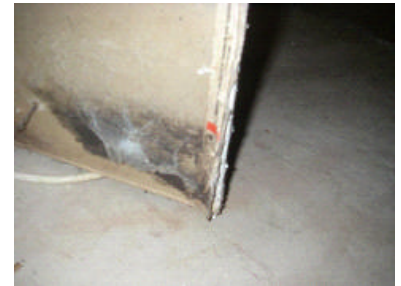
- Stains were observed on the wall at *****. When checked with a moisture meter the area indicated a wet / active leak condition. Recommend further evaluation and repair as needed by a qualified / licensed contractor. Please refer to limitations of inspection regarding mold / moisture related conditions.

- Evidence of suspected mold or mold related stains / discoloration was observed at *****. When tested with a moisture meter, the areas indicated a dry condition at the time of inspection. This may not, however, be an indication of future conditions. We suspect this area was subjected to water or high moisture at one time. A mold inspection or testing was not performed as part of this general home inspection. Client is advised to consult a qualified mold testing company and the EPA website <http://www.epa.gov/iaq/molds/moldguide.html> prior to close regarding testing and treatment. Refer to limitations of inspection and our inspection agreement.

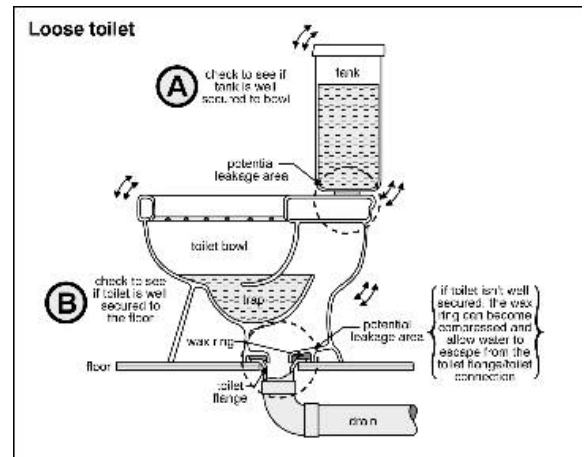
- The toilet was loose at the floor. Recommend securing / repair as needed by a licensed plumber. While this condition is somewhat common, it can increase the likelihood that some water penetration may have occurred at the base / wax seal area of the floor.
