Inspection Report
95 Old Stage Road
East Brunswick NJ
Scott Frederick

Report Table of Contents

DATE OF INSPECTION:
August 18, 2009.

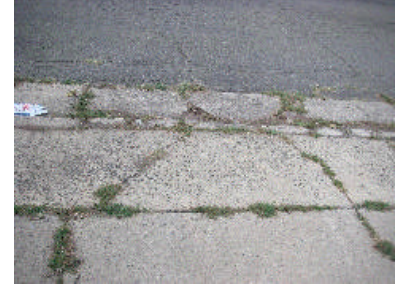
- Significant cracks were observed at the sidewalk or walkway. These cracks warrant further attention and / or repair.

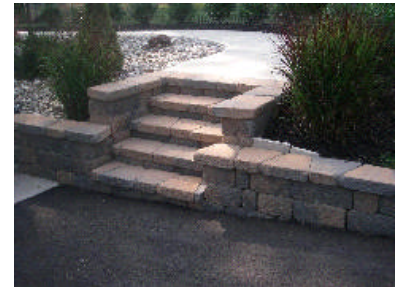
- The retaining walls are, block, The visible and accessible portions of the retaining walls appeared to be in serviceable condition at the time of the inspection.

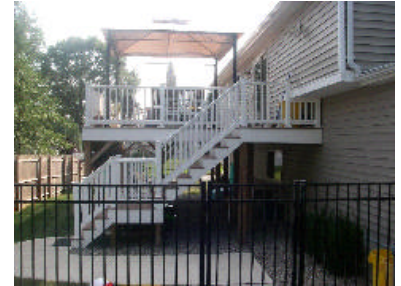
- The visible and accessible areas of the deck appeared to be in serviceable condition at the time of the inspection.

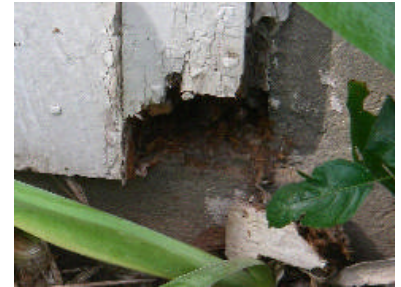
- Moisture related damage to the trim was observed at *****. Recommend repair to damaged areas. Concealed evidence may exist in areas not readily visible. Further evaluation would require removal of wallboards, which is not performed as part of this inspection.

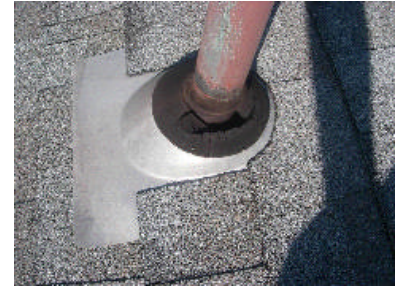
- Sealing of flashings is needed at plumbing, vent pipes, chimney, wall, valley seams, (skylights if present) and any other through roof projections.

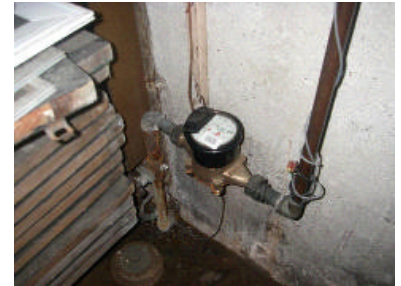
- The visible material of the main line / pipe coming in from the street appears to be copper.
- **The main valve is located at the basement.**

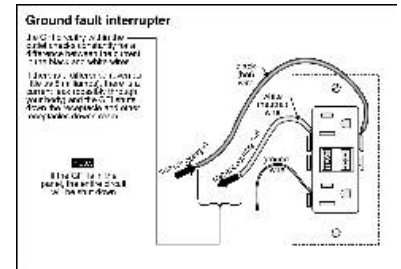
Only some GFCI receptacles were present. Where not present, GFCI receptacles are recommended at bathroom(s), kitchen, exterior, and garage (if present).

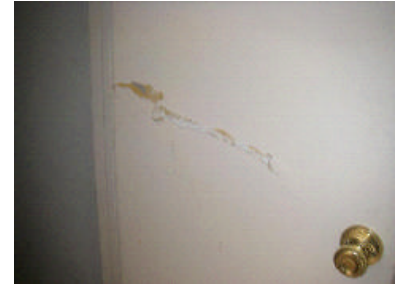
- The interior door(s) were damaged. Recommend repair or replacement as needed.

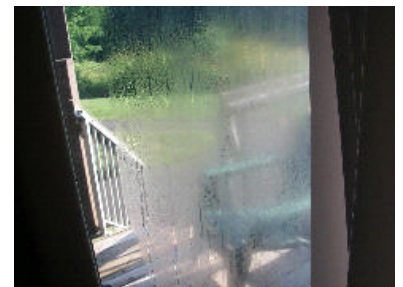
- The thermal pane exterior door(s) appears to have lost its / their thermal seal. An indication that thermal glass doors have lost their thermal seal is moisture, condensation, and hazing between the panes. While mostly cosmetic, this condition is generally not repairable and the door(s) will most likely need replacement at some point.

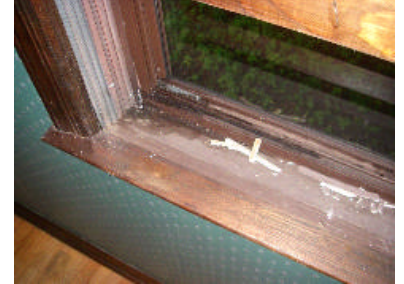
- Exterior frame weathering and some deterioration was observed at the window sills. Recommend repairs / maintenance as needed. Water penetration may have occurred.
- The *****windows would not remain in the open position. Broken or worn sash cords or springs were noted. Recommend repairs as needed.

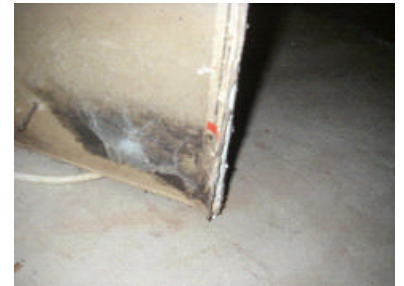
- Stains were observed on the wall at *****. When checked with a moisture meter the area indicated a wet / active leak condition. Recommend further evaluation and repair as needed by a qualified / licensed contractor. Please refer to limitations of inspection regarding mold / moisture related conditions.

- Evidence of suspected mold or mold related stains / discoloration was observed at *****. When tested with a moisture meter, the areas indicated a dry condition at the time of inspection. This may not, however, be an indication of future conditions. We suspect this area was subjected to water or high moisture at one time. A mold inspection or testing was not performed as part of this general home inspection. Client is advised to consult a qualified mold testing company and the EPA website <http://www.epa.gov/iaq/molds/moldguide.html> prior to close regarding testing and treatment. Refer to limitations of inspection and our inspection agreement.

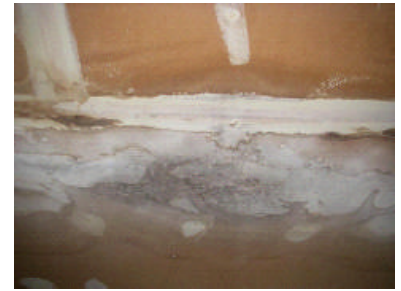
There were moisture stains on the ceiling at bedrooms, When tested with a moisture meter, the stained area indicated a dry condition at the time of inspection. This is not an indication of future conditions. Please refer to limitations of inspection regarding mold / moisture related conditions.

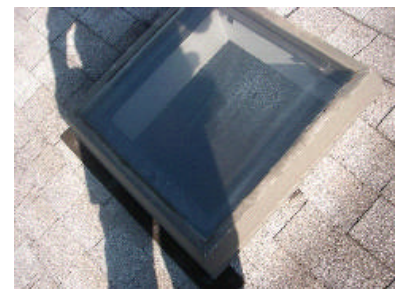
- The thermal pane skylight appears to have lost its thermal seal. An indication that thermal glass has lost its thermal seal is moisture, condensation, and hazing between the panes. While mostly cosmetic, this condition is generally not repairable and replacement is needed. Depending on the pitch of the roof, manufacturer, and installation procedures, skylights can be fairly high maintenance components. Skylights generally require exterior sealing at some point to reduce the possibility of leakage.

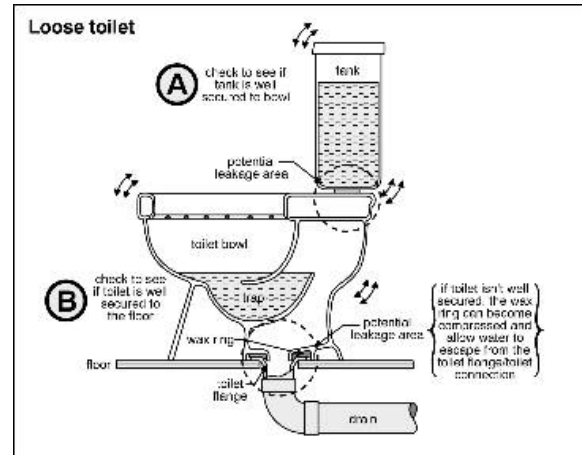
- The toilet was loose at the floor. Recommend securing / repair as needed by a licensed plumber. While this condition is somewhat common, it can increase the likelihood that some water penetration may have occurred at the base / wax seal area of the floor.
